# Manhole Inspection Summary

Manhole # S15A\_\_037MH

Insp Date: **7/2/08 4:56 PM**

**Location** Address: **714 WHITMORE**

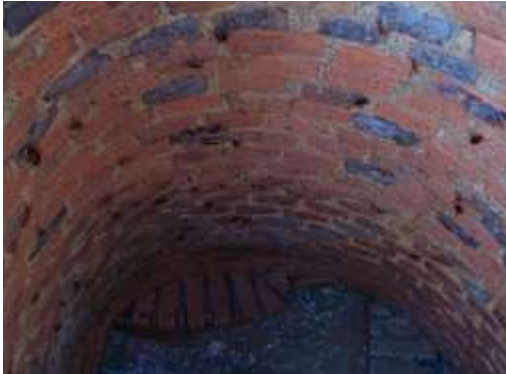
Defect 3

ROOT INTRUSION AND ROOT INFILTRATION, CORBEL/BARREL

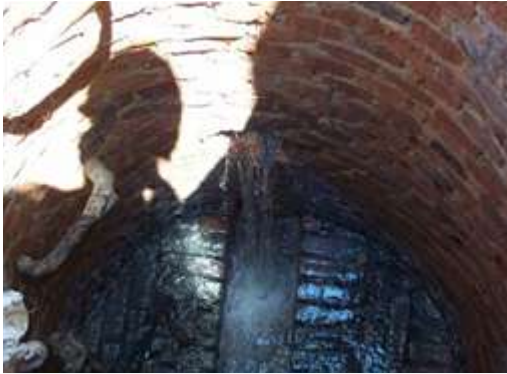
Defect 1

ROOT INTRUSION BARREL, WALL

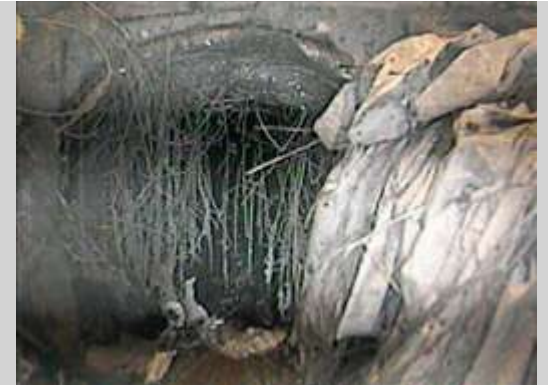
12 O'Clock Outflow

8 in. Circular Gravity Sewer  
Pipe Out @ 12 O'Clock

Infiltration: **None** Pipe Seal Cond: **Roots**

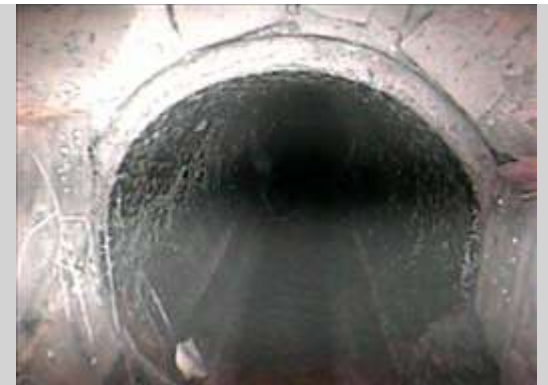
6 O'Clock Inflow

8 in. Circular Gravity Sewer  
Pipe In @ 6 O'Clock

Infiltration: **None** Pipe Seal Cond: **Sound**
